Analysis of Remote Minehunting System Vehicle Sensor and Sonar Data Reveals System Problems

Technical Memorandum

DRDC Atlantic TM 2004-256

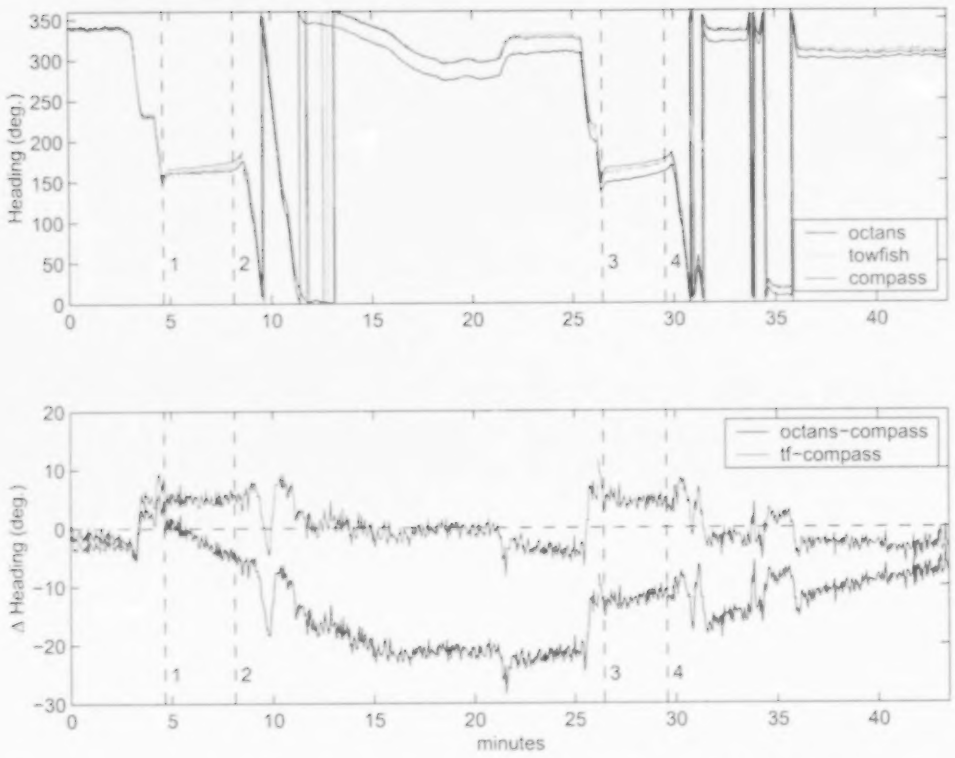
It appears that the heading output by the Octans was unreliable during the trial. Over periods of about 45 minutes to an hour, the Octans heading output gradually wandered off by +/-10–20° then returned. This happened several times during the trial, no more than once a day, starting at seemingly random times, regardless of whether compass calibration exercises (a series of long legs at constant headings) were performed or not. Octans heading in the 10 Hz "fast" vehicle logs can be compared to another log field "vcc_compass_fb_deg" (though I am unsure of the source of this information), and to towfish heading when the towfish INU (PHINS) was functioning properly, keeping in mind that the towfish follows the vehicle on its own track. Figure 1 shows a typical example from May 7. Figure 2 shows the vehicle track during this time period overlayed with two sets of instantaneous heading arrows: the Octans heading is shown in red and the "compass" heading is in black.

Figure 1: *Time series of heading measurements showing Octans (blue), PHINS towfish (green) and "compass" (red) heading outputs over a 45 minute period in the upper plot. The lower plot shows the difference between Octans and "compass" (blue) and between towfish and "compass" (red) headings over the same time period. Numbered vertical lines show approximate start and stop times of bathymetric survey lines.*

Over the 45 minute period shown, the difference between Octans and "compass" heading increases to about 20°, then returns to small values. In the plan view plot, the black arrows ("compass") generally agree with the course of the vehicle, while the Octans heading is slewed to port.

Two bathymetric survey lines were run during this time period, between the labels "1" and "2" and between "3" and "4". Octans heading was input directly to the Reson processor and hence into the recorded bathymetry data files. Usually it so happened that the Octans heading was in line with what it should be during bathymetric measurements. The data files containing bad heading data were repaired by importing a course–made–good using the CARIS Generic Data Parser. Note that the "vec_dgps_course_true_fb_deg" vehicle log data during this trial was also quite unreliable, showing long periods of essentially noise.

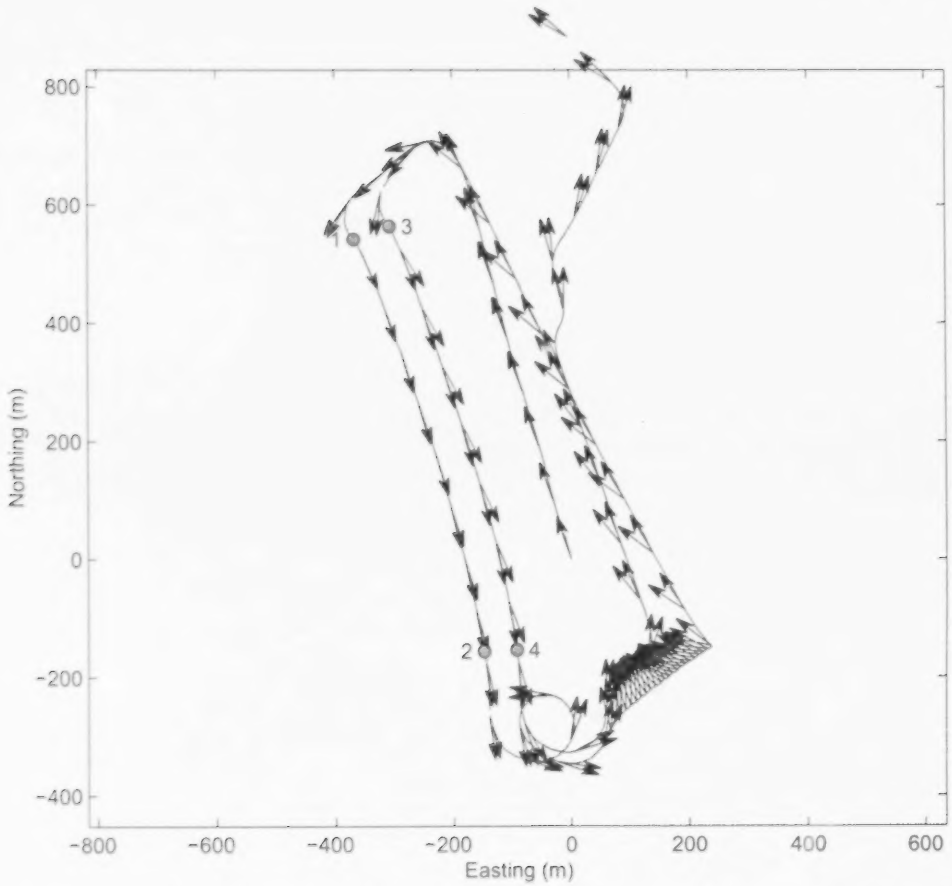
Figure 2: *Plan view of vehicle track associated with the time series shown in the previous Figure with instantaneous heading indicated by the arrows: red arrows are Octans and black are "compass". The labelled green dots correspond to the numbered vertical dashed lines in the previous Figure.*

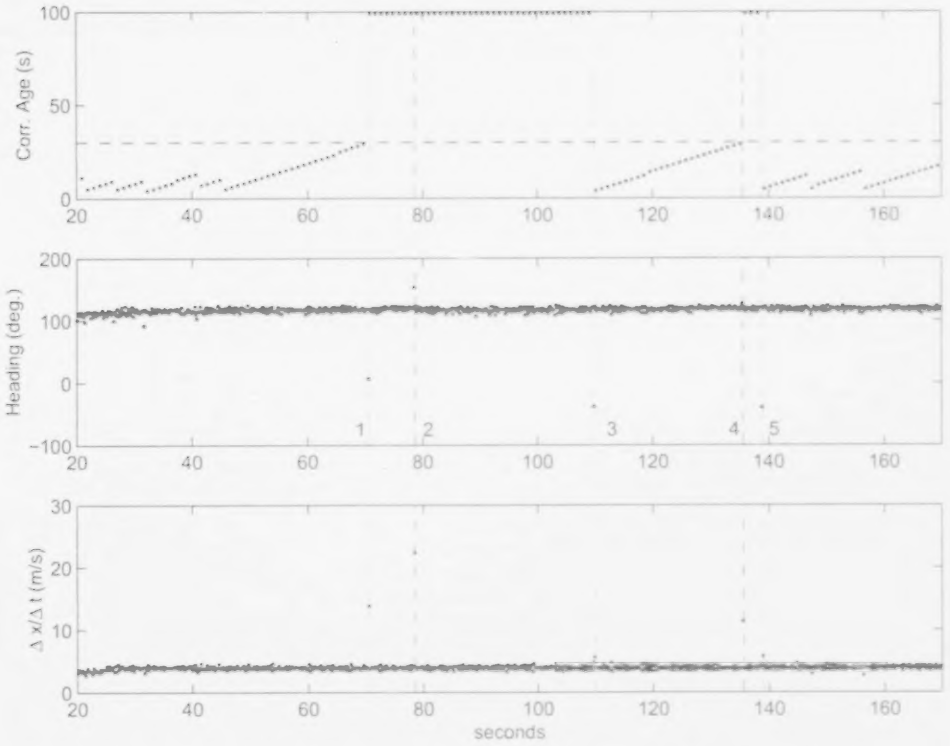
Figure 3 shows sample "fast" and "slow" (1 Hz) vehicle log data summarizing typical DGPS positioning performance during the trial. The upper plot shows the reported age of the current differential correction in seconds. The dashed horizontal line indicates an age of 30 s and anything older is given a value of 99 s. The middle plot shows the heading between consecutive vehicle positions

Figure 3: *Time series of GPS parameters: age of the differential correction (top), position–to–position heading (middle), and position–to–position distance over time (bottom). Vertical dashed lines and numbers label "jumps" in position, characterized by discontinuities in heading or displacement.*

(blue dots, $\arctan(\Delta x/\Delta y)$ with x and y in UTM Easting, Northing coordinates) along with the vehicle heading reported by the Racal (red line). The bottom plot shows the distance travelled between positions divided by the time elapsed (blue dots) and the vehicle speed reported by the Racal (red line). The update rate of the Racal (about 2 Hz) is about half the sample rate of the fast vehicle logs, so duplicate positions returning nonsense heading and zero Δx values have been removed and accounted for in the calculations. The vertical dashed lines with number labels indicate times where the vehicle track "jumps" with discontinuities in either heading or distance travelled, or both. Figure 4 illustrates in plan view the associated track of the vehicle during this time period, with the 5 jumps shown in Figure 3 magnified in the insets.

The jumps most often coincide with either the >30–s–old expiry or reacquisition of differential corrections — it seems like the Racal does not use differential corrections older than 30 s and switches to an uncorrected mode. The frequency of update of the differential corrections as either supplied by the Landstar network or successfully received by the Racal unit (not clear which), is

The problem with the quality of the DGPS positioning can be solved by switching to a new or better GPS receiver. For trials in regular operating areas, shore–based differential corrections can be used for free. The Octans heading and heave problems are matters of instrument settings and tuning the system. The Reson ping rate vs. survey speed problem is a matter of operational experience. The underestimation of altitude by the DVL may perhaps be considered as a safety margin when operating in terrain–following mode and only affects georeferencing of the sidescan data significantly in the near–nadir area. The Reson sound speed probe can perhaps be moved to sample external to the vehicle hull, though it needs to be in a location where flow will not carry significant numbers of bubbles through the sample volume.

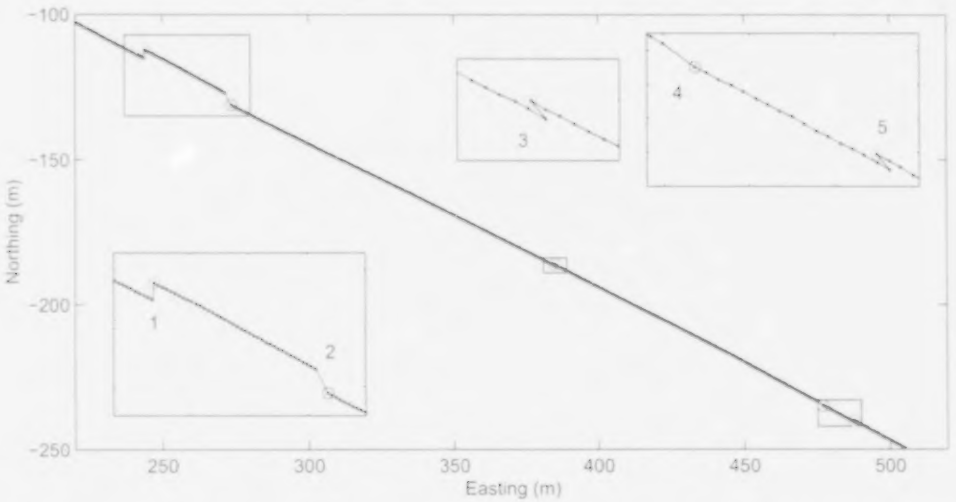
Figure 4: *Plan view of vehicle track associated with the time series shown in the previous Figure. The insets magnify the labelled jumps in position.*

Qualitative comparison between vehicle tracks recorded off Esquimalt during Build 3 (no differential correction) and during the Victoria 2004 trial show the Landstar differential correction gives no great improvement, in the sense that there are as frequent or even more jumps occurring as the Racal switches in and out of differential mode every few minutes. These jumps skip about the same horizontal distance as the jumps commonly seen in regular uncorrected GPS mode. Andrew Westwell-Roper notes in the Build 3 Trials Report that during Build 3 there was a 10 m north–south offset between shore–station–supplied differential correction (GIBS) positions and the vehicle uncorrected GPS positions — presumably long term bulk positioning offsets like this should be eliminated by the differential correction. On the shorter term, offsets of the vehicle track such as between labels 1 and 2 in Figure 4 could contribute to positioning error.

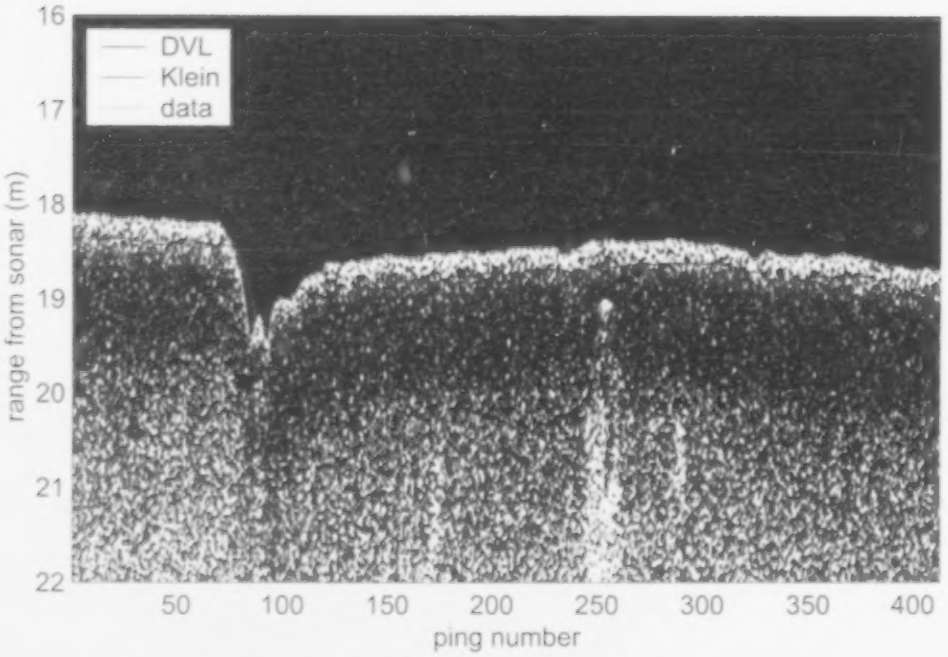
Figure 5 shows an example of altitude measured by the Doppler Velocity Log (DVL), by the Klein altimeter, and derived from the sidescan sonar data itself. Over a flat seabed and while the towfish is travelling without significant roll or pitch accelerations, the DVL performs well as an altimeter, but otherwise underestimates the distance to the seabed. RDI claims 1% accuracy in range to bottom measurements by the Workhorse Navigator 300 DVL (http://www.dvlnav.com/the_facts.html). The Klein altimeter is unreliable apparently due to low signal level with frequent dropouts, though it is performing normally in the sample of data shown here — it usually over–estimates altitude slightly, and lags sudden changes due to filtering of the output. Algorithms that were developed for deriving altitude from the first return in the sidescan sonar data itself are not reliable when applied to the RMS data also due to the low signal level (see discussion in the following section).

The inaccuracies in towfish altitude measurement are small (<3%), so they do not affect either terrain–following or sidescan data georeferencing greatly.

Figure 5: *Comparison of altitude measurements by DVL (blue), Klein altimeter (red) and derived from the sonar data (green), overlayed on scaled raw sonar data.*

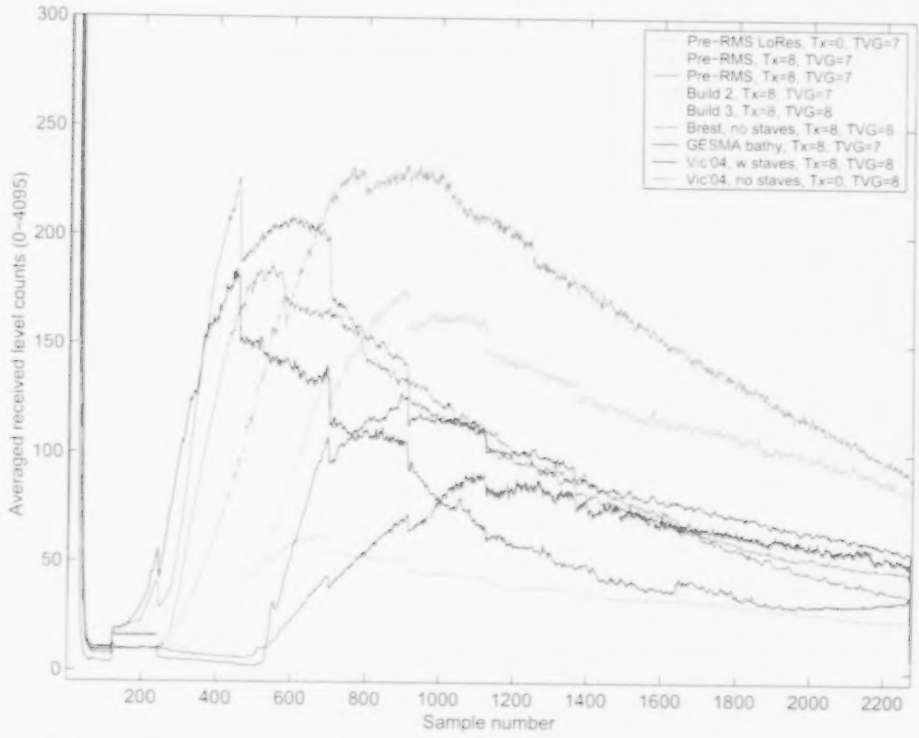
***Figure 6**: Comparison of averaged signal levels from several Klein deployments. Several thousand port and starboard pings are averaged in each case. Deployments are in chronological order in the legend, with the transmit pulse (Tx) and TVG settings indicated for each.*

Several conclusions can be drawn from the complicated plots shown in Figures 6 and 7. The three examples of pre-RMS data illustrate the wide range of received signal levels over varying seabed types, with the lowest levels from a site in Herring Cove (listed third in the legend) falling below most of the others, including some of the RMS data. The lowest averaged levels shown are from the Build 2 deployment when this issue was raised as a concern. In the representative examples shown

here, the level increased for the Build 3 deployment (increased TVG setting), and again for the Victoria 2004 trial (while not recording the stave data, the full transmit array was used). Comparing the two Victoria 2004 trial examples, there is a significant decrease in signal level in the beamformed data while logging the raw stave data, which may be due to the decreased transmit array or some change in the Klein on–board signal processing when operating in this mode. The peaks of the distributions for the pre–RMS data are at higher levels than the RMS data, though not by much in the case of the Herring Cove data. The high end tails of the distributions show an increase in the same progression as the averaged levels from Build 2 through to the Victoria 2004 trial. Comparing DRDC's Klein with the GESMA Klein, the distribution peaks at lower signal level, even though the TVG setting is higher, however it is perhaps dangerous to compare two sonars which have both had significant post–factory modifications. The Aurora towfish, into which the Klein is integrated as part of the RMS, was completely rebuilt between the trial in Brest Harbour and the Victoria 2004 trial. The distribution for the Victoria 2004 trial (without stave data) peaks at the highest signal level of all the examples of RMS Klein data, spreads wider into higher signal levels, and more closely resembles the distribution of pre–RMS and GESMA (stand–alone) Klein signal levels.

To summarize this discussion, the signal level has been much improved since it was noted as being low in Build 2, by increasing the TVG setting and using the full array transmit pulse. Increasing the TVG setting is a less than optimal solution, however, since this amplifies signal and noise indiscriminately. As well, using the full transmit array is not ideal when operating the sonar in high resolution mode. Though still appearing to have lower averaged levels than in the pre–RMS deployments, the signal level distribution now resembles pre–RMS distributions more closely since the rebuild of the Aurora prior to the most recent trial. Further dedicated testing would be required to determine this absolutely, such as a pair of surveys of a well characterized area with the Klein by itself and as part of the RMS.

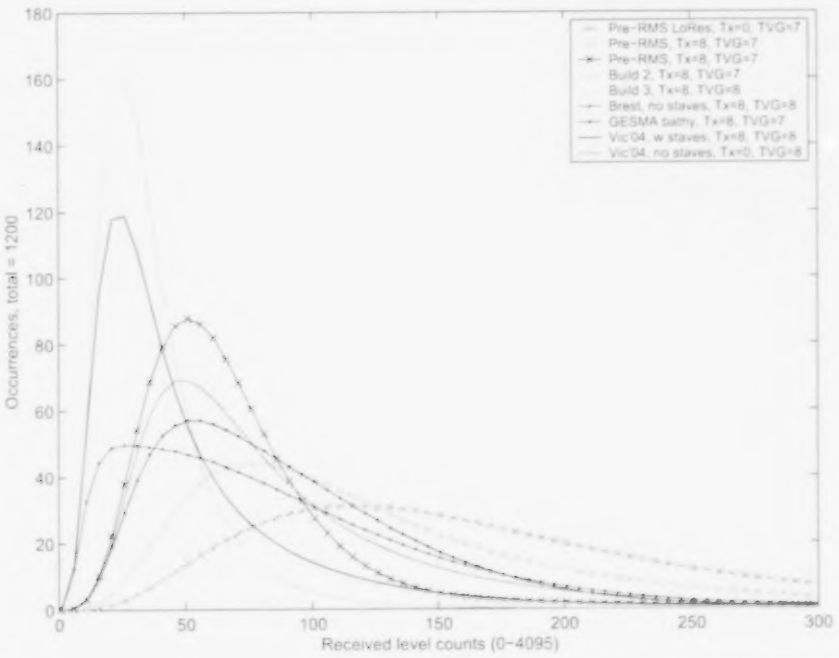
Another way of looking at the same information is as distributions of signal level, shown in Figure 7. To minimize the effect of the different sonar altitudes and noise contributions, only samples 800 to 2000 in each ping (approximately 25 to 65 m range, between the red dashed lines in Figure 6) have been counted. The distributions have been normalized by the number of pings, so the integrated area under each curve equals the number of samples used from a ping (1200).

Figure 7: *Comparison of signal level distributions from several Klein deployments. The RMS Klein data has been "despeckled" for comparison with the pre–RMS data.*

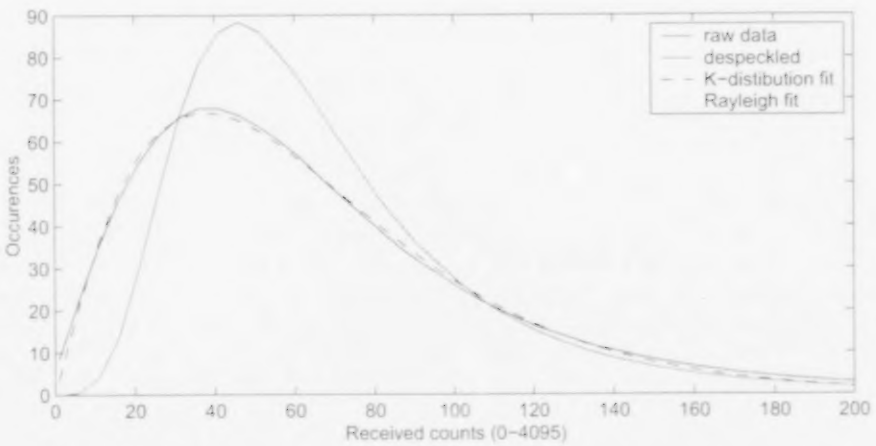
an along–ping 3–sample boxcar filter, emulating a Klein despeckle filter setting of 1. The effect of the filter can be seen in Figure 8, which shows the distributions of the Victoria 2004 data recorded without the stave data, filtered and unfiltered, along with fitted theoretical distributions. The low end of the despeckled distribution is greatly reduced and the peak increased and shifted slightly toward higher signal level. The effect on ensemble averaged ping data like that shown in Figure 6 is negligible. The unfiltered data is well matched to a K–distribution, also shown in Figure 8, while the filtered data has closer to a Rayleigh distribution. Seabed classification schemes operating on the statistics of the seabed backscatter would likely be affected by the despeckle filter, hence its discontinued use.

Figure 8: *Effect of despeckle filtering on signal level distribution.*

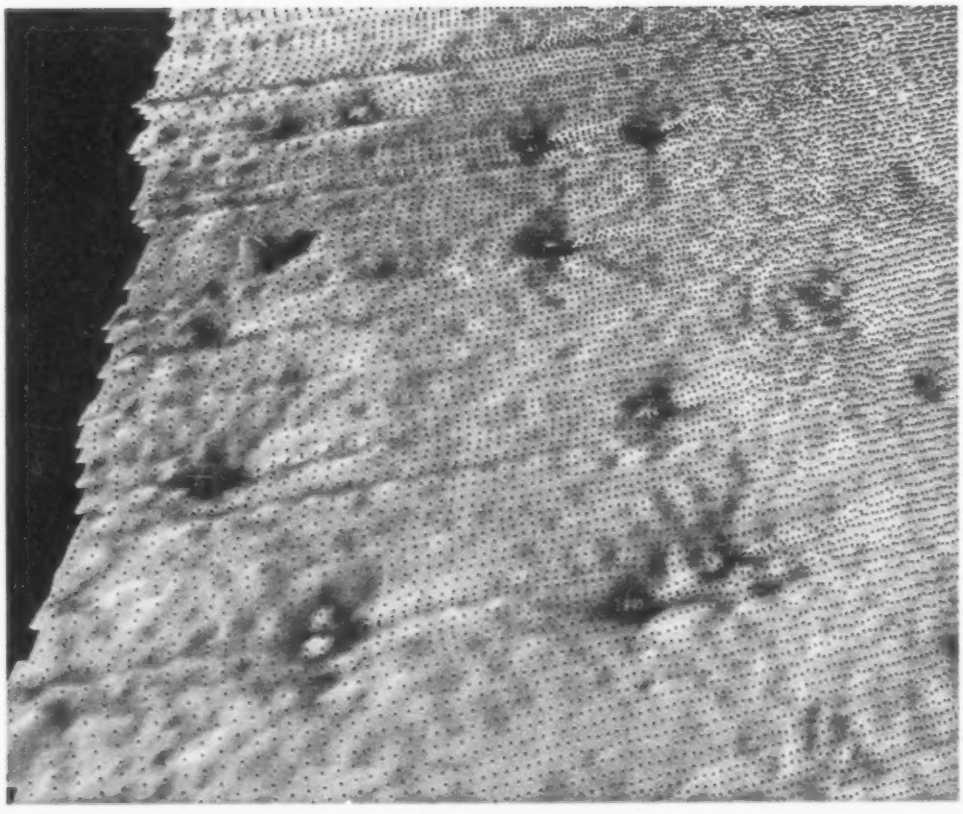
In order not to overload the radio communication channel between the Dorado and support vessel, the Reson ping rate was kept at a bare minimum, even though the data link was probably capable. At times, this meant that at the customary Dorado survey speed of 6–8 knots, the coverage of the resulting bathymetric survey data was not up to requirements. For example, several passes over the '88 Array yielded bathymetry data with too coarse resolution to resolve the targets clearly since soundings from consecutive pings were separated by 1–1.5 m on the seabed. Figure 9 shows a sample of this data. The sounding density is only barely adequate to resolve the large scour holes surrounding the targets. At that location with 50 m water depth, the maximum ping rate of the Reson is about 5 Hz and at that time, it was set at 3 Hz. In theory, with perfect positioning, repeat overlapping passes should fill in the gaps, however in practice, this is hit–or–miss (see the discussion on GPS positioning). It is better to survey at a slower speed with the maximum ping rate allowed by the water depth.

Figure 9: *Sample of processed bathymetric survey data (1 m grid spacing) over the '88 Array, with the individual soundings shown as black dots. The view angle is oblique from a 45 degree elevation, looking northward. Some of the array target locations are marked with red + symbols.*
